# Laurens County Tornado of 13 January 2005

## Survey and Assessment of Storm Damage

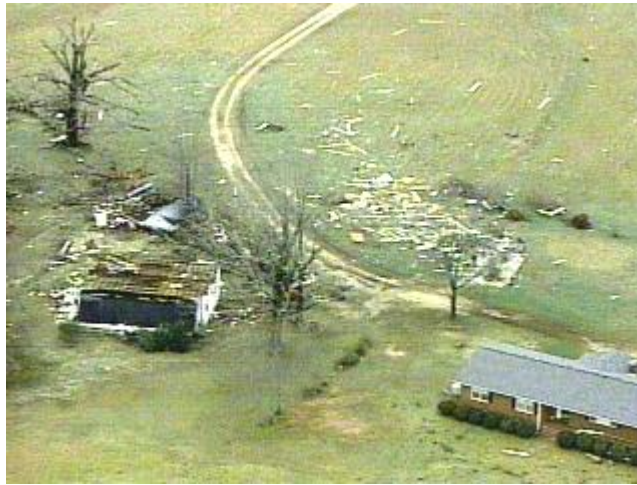
Fig. 4. Damaged structures near Laurens High School. Note the destroyed mobile home. The school is approximately 170 yards to the left of the left edge of the picture. Photograph from WYFF-TV.

The long track portion of the storm consisted of mostly F0 and F1 damage. However, there were at least two locations (just east of Laurens High School and near Welcome Church Road) where mobile homes were completely destroyed. Also, many large deciduous trees barren of leaves were uprooted. This mobile home and tree damage is consistent with F2 intensity on the Fujita scale of tornado intensity. The WSR-88D TVS persisted along this portion of the storm track.

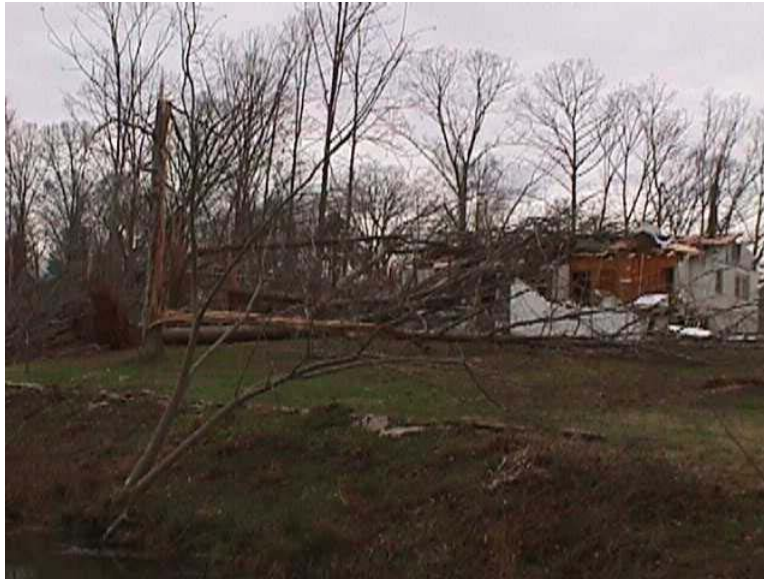
A damage track extended from the high school area northeast through woods to Whelon Road where many large trees were uprooted and moderate damage to a frame guest house was observed. (Tip of arrow B in Figure 3.) It was not possible to differentiate wind damage from tree damage on the guest house. The main residence, approximately 100 yards to the northwest, was not significantly damaged, but a tractor parked nearby was toppled. The aerial view in Figure 10 clearly shows the direction of the strongest winds which occurred on the right side (relative to the direction of motion) of the tornado. Nearly all of the trees are pointing toward the northeast. A close examination of the tree damage reveals several trees were uprooted or snapped by a wind with a westerly component. Also, the trees that fell toward the east are on top of the trees aligned with the primary wind flow. The layering of debris with varying directional distribution

Fig. 7. Downed trees and a damaged structure near the pond on the west side of Whelon Road. NWS photograph.

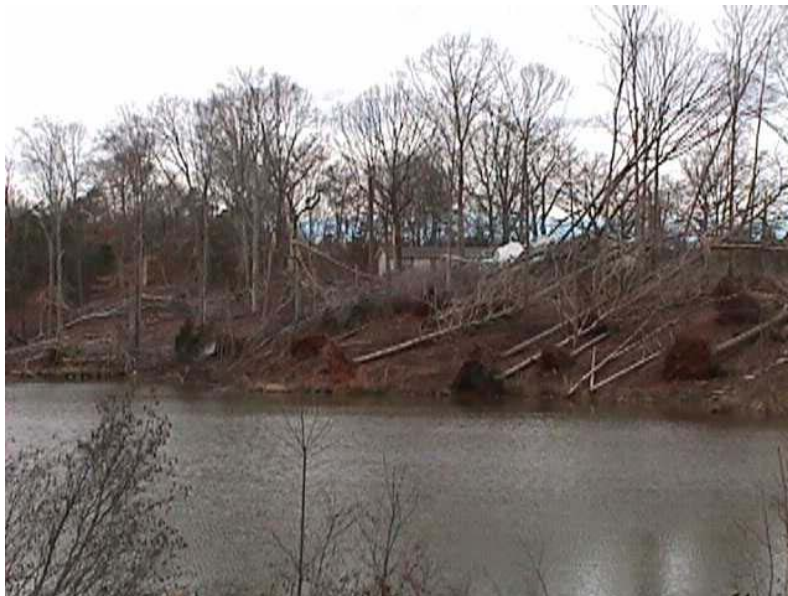
Fig. 8. Trees uprooted along the north side of the pond on the west side of Whelon Road. NWS photograph.

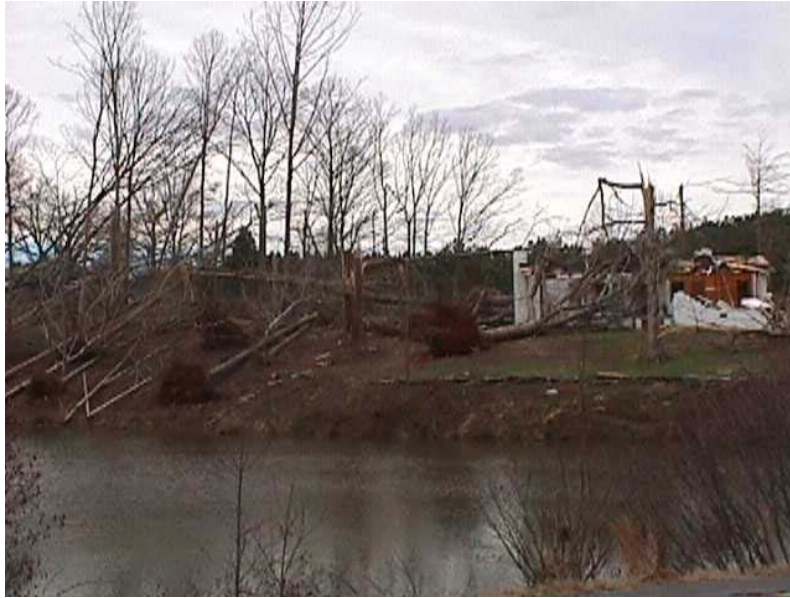
Fig. 9. Another view of the tree and structure damage on the west side of Whelon Road. NWS photograph.

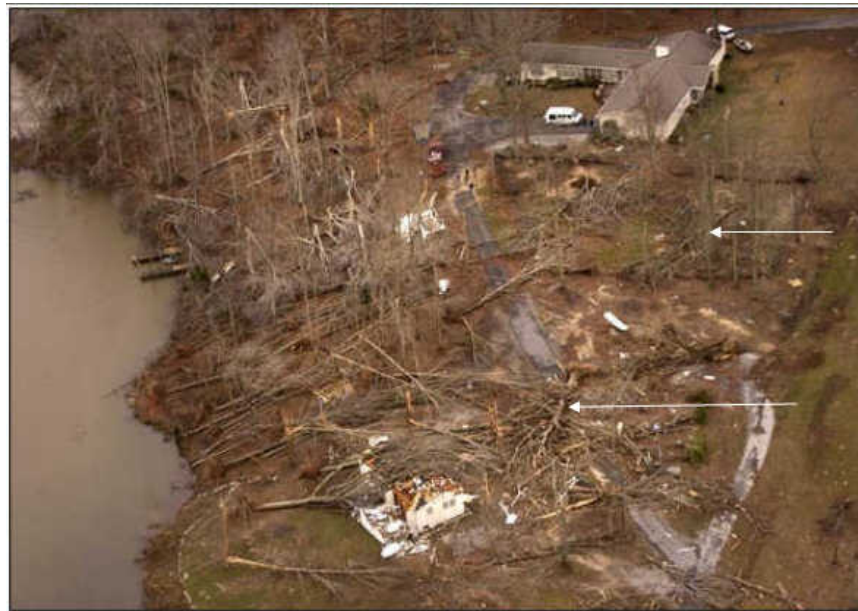
indicates that the westerly winds occurred after the southerly winds produced most of the damage. This sequence of tree damage corresponds to that expected with a cyclonic circulation moving toward the northeast.

Fig. 10. Aerial view of the damage seen in Figures 7, 8, and 9. A residence is at the top of the picture, and a guest house is near the bottom. Most of the downed trees are aligned in a southwest to northeast direction indicating the strongest, most damaging winds blew from the south or southwest. Arrows point toward trees uprooted and toppled by wind with a predominant westerly component. Photograph courtesy of *The Greenville News*.

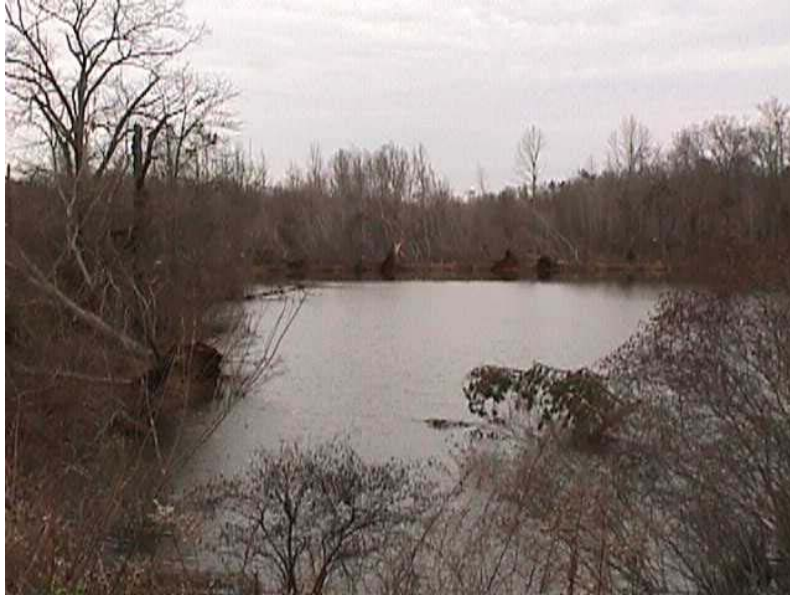
Fig. 11. A view across the pond on the east side of Whelon Road. Note the root balls of uprooted trees on the distant shore. NWS photograph.

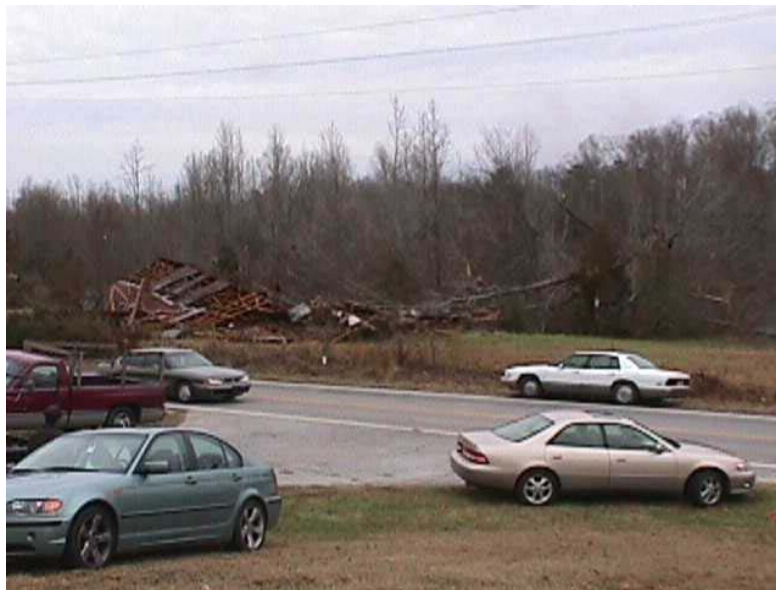
Fig. 12. Destroyed structure (probably a barn) on the east side of Whelon Road approximately 200 yards northeast of the damaged guest house pictured in Figure 9. View is toward the northeast. NWS photograph.

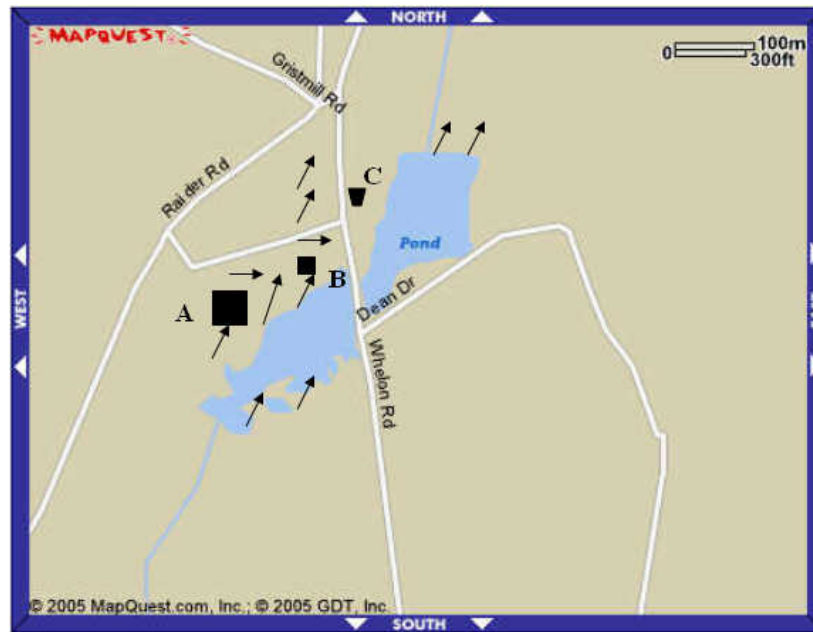
Fig. 13. Schematic diagram of the area pictured in Figures 7-12. Arrows represent direction in which downed trees are oriented. A and B represent the two houses seen in Figure 10. C identifies the destroyed barn seen in Figure 12.

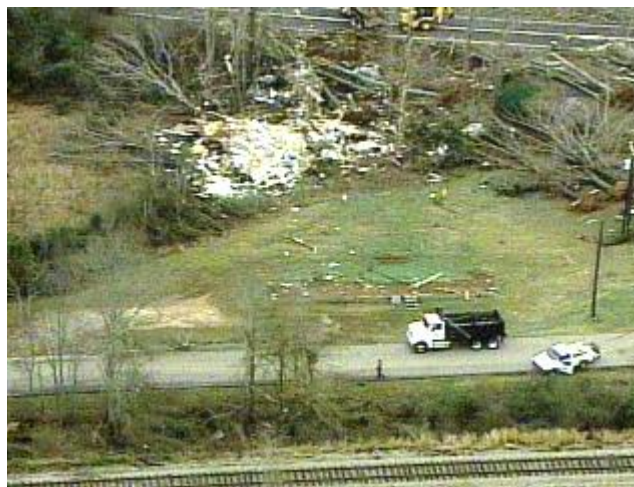
Fig. 14. Destroyed mobile home on Welcome Church Road. The steps and rectangular grass-free area identify the original location of the structure just above the truck. Photograph courtesy of WYFF-TV.

The tree damage and the debris pictured in Figure 14 clearly indicate the wind encountered the mobile home nearly broadside. This orientation resulted in an optimum situation for displacing and moving the structure, particularly if it was not anchored to the ground.

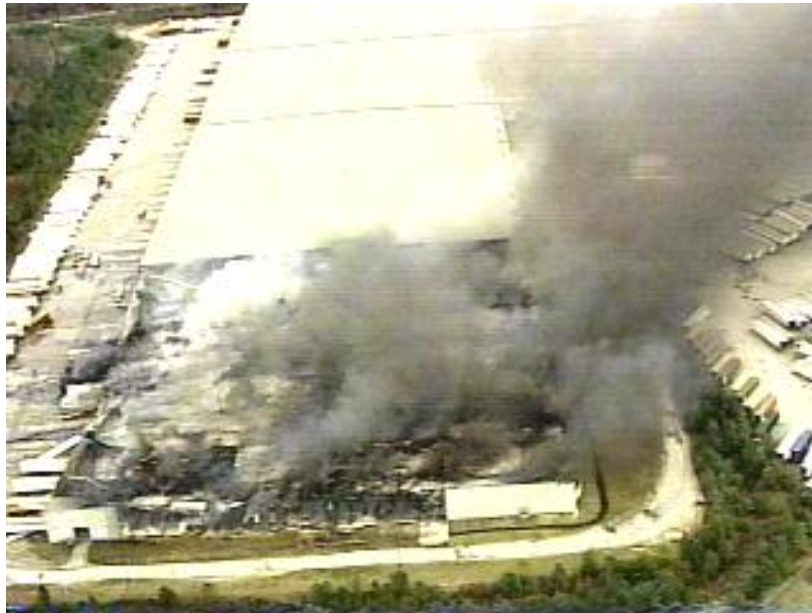
Fig. 15. Fire smoldering at the TNT Logistics facility on the day after the storm. Photograph courtesy of WYFF-TV.

The damage to the TNT Logistics facility and nearby trees is determined to be F1 tornado damage. The WSR-88D TVS had weakened at this point, but it reappeared when the storm was approaching Enoree in extreme southern Spartanburg County. No evidence of wind damage has been found along the remainder of the storm’s track through Laurens County into Spartanburg County. However, reports were received at the WFO shortly
